PASSAIC RIVER BASIN
STONE HOUSE BROOK, MORRIS COUNTY
NEW JERSEY

LOWER KAKEOUT DAM NJ 00822

PHASE 1 INSPECTION REPORT NATIONAL DAM SAFETY PROGRAM

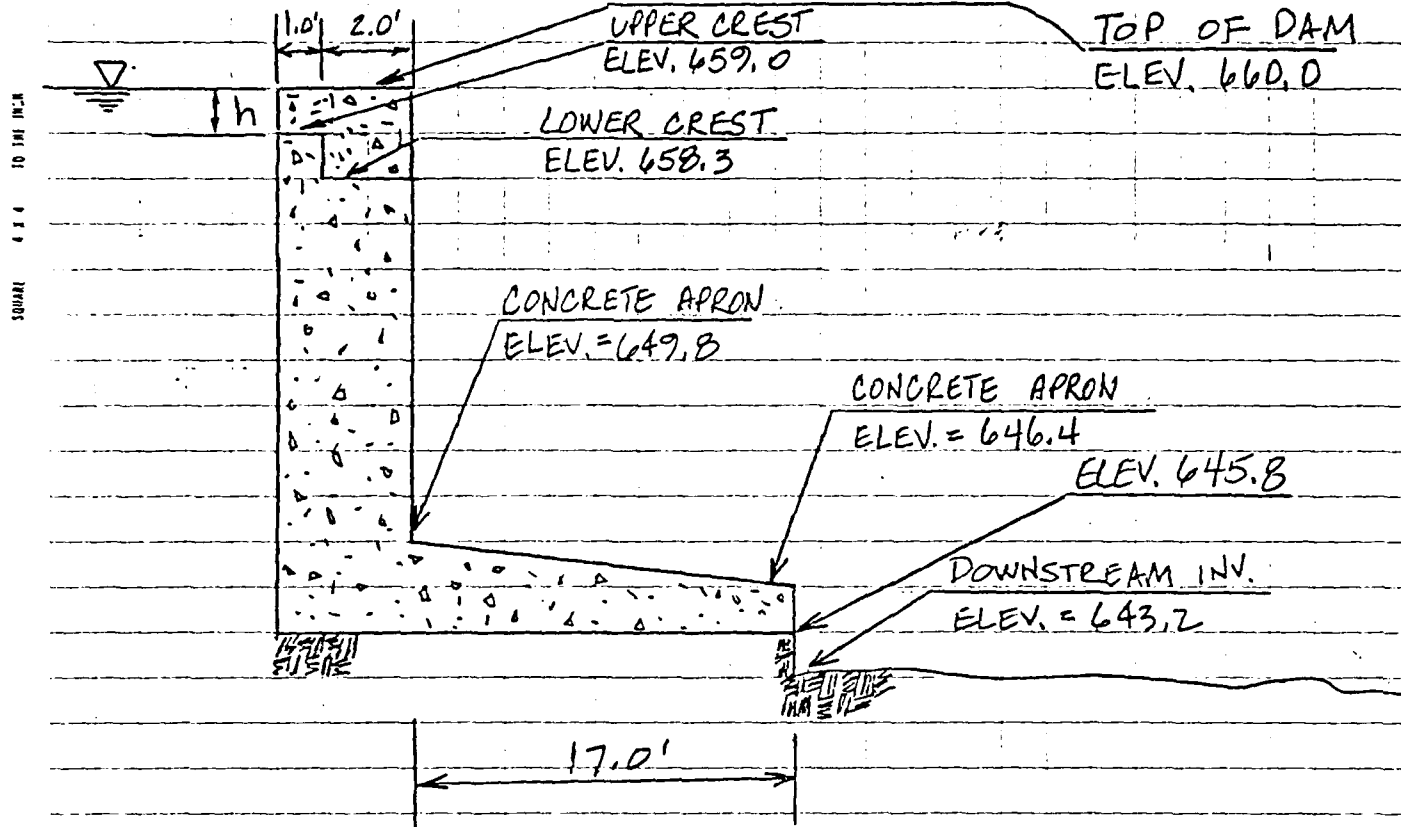
SPILLWAY STAGE DISCHARGE TABULATION

PRINCIPAL SPILLWAY				
ELEV.	C	L	H'	Q
659.0		49.5		
659.5	2.74	49.5	0.5	47.9
660.0	2.98	49.5	1.0	147.5
661.0	3.30	49.5	2.0	462.0
662.0	3.32	49.5	3.0	853.9
663.0	3.32	49.5	4.0	1314.7
664.0	3.32	49.5	5.0	1837.4
665.0	3.32	49.5	6.0	2415.3
666.0	3.32	49.5	7.0	3043.6
667.0	3.32	49.5	8.0	3718.4

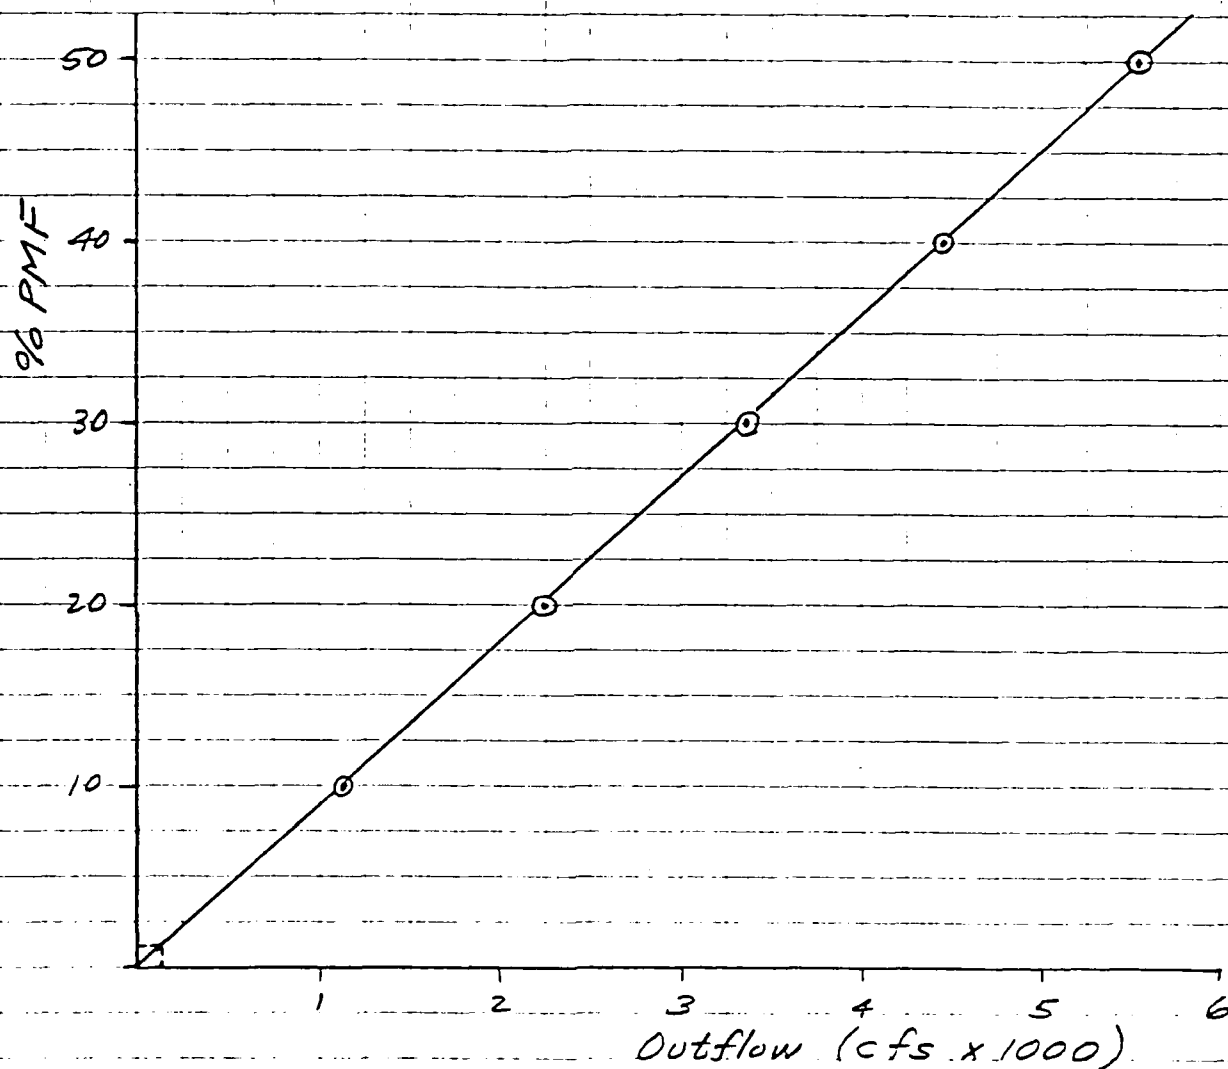
OVERTOPPING POTENTIAL

Dam overtopping occurs at elev. 660.0
with a discharge $Q = 148$ c.f.s.

The dam can pass approx. 1% PMF

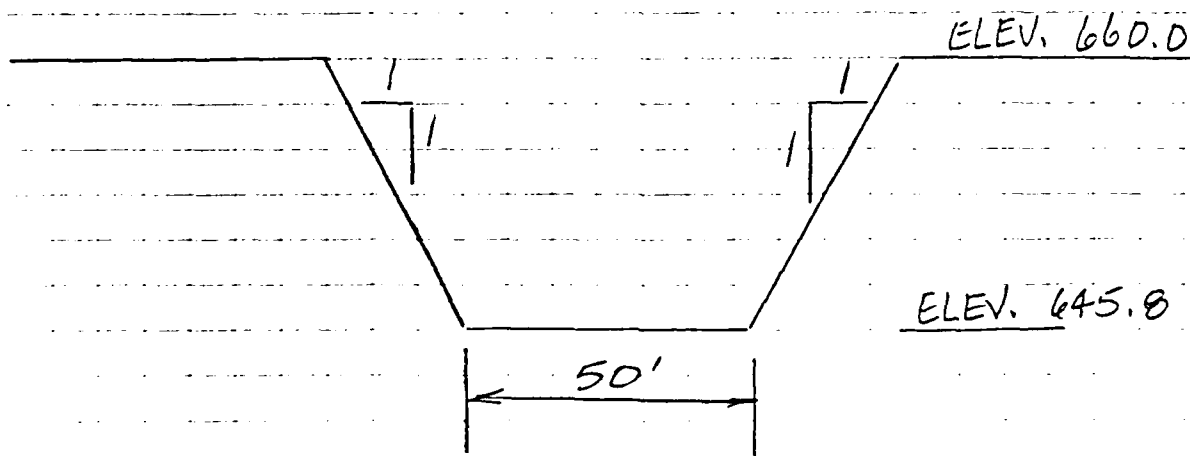
FULLY DEVELOPED BREACH

1. THE BREACH BEGINS WHEN THE WATER
SURFACE ELEVATION REACHES 660.0
2. TIME TO DEVELOP BREACH = 2.0 HR.
3. SECTION:
